August 1, 2018

**Subject: Geotechnical opinions of south and north bank fish ladder construction options at Scott Dam**

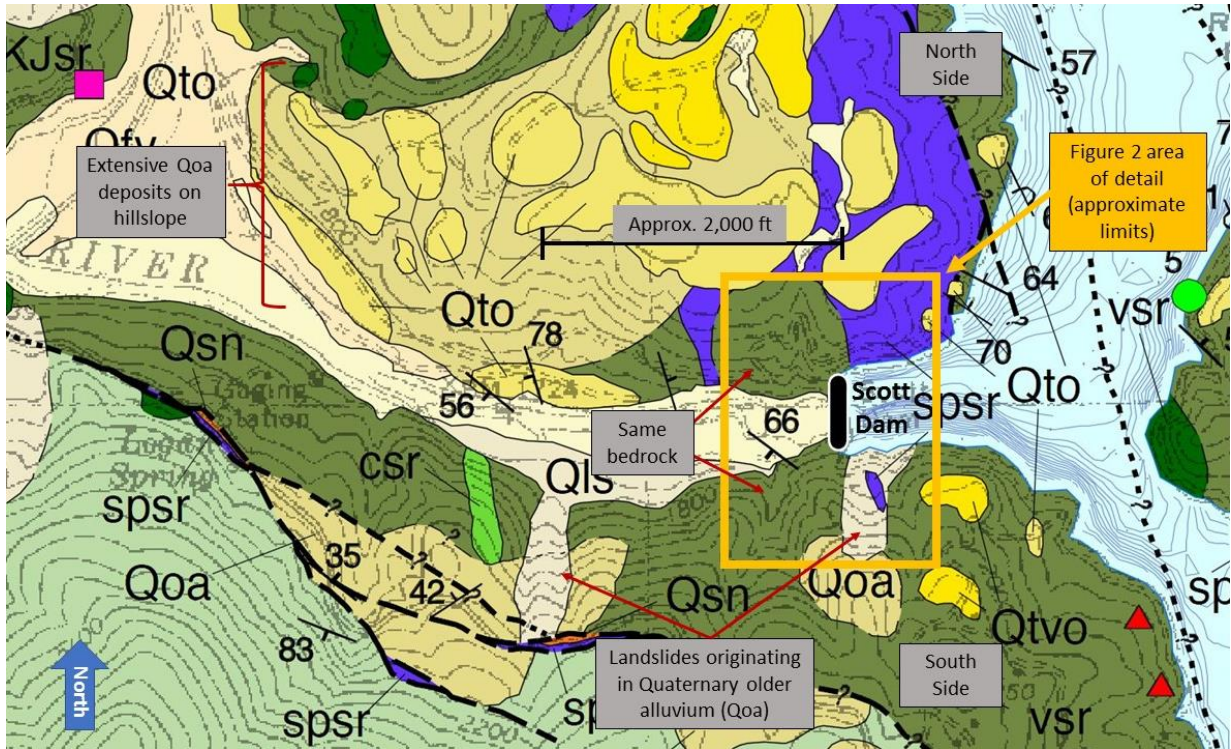
Ohlin et al. (2010) show three large landslides on the south bank, all having originated in older alluvial deposits, which suggests that the alluvial deposits are susceptible to mass wasting (Figure 1). As part of a more detailed site-specific investigation, PG&E (2016) summarize the geology and geomorphology at Scott Dam, both in the immediate up- and downstream vicinity. Their mapping is at a much higher resolution than Ohlin et al. (2010), and shows additional earthflows, slumps, and debris flows on both the north and south bank (Figure 2). The most attention in their report has been given to the large landslide complex located on the south bank adjacent to the left bank dam abutment (called the “1920 slide”, this is one of the three slides also mapped by Ohlin et al. 2010; see PG&E 2016 for additional detail and discussion of historic mapping, monitoring, and related analyses). The PG&E investigation is focused primarily on the south bank and contains limited mapping and description of the north bank, yet the north bank mapping identifies three headscarps (topographic features showing displacement resulting from past landslide activity) showing some mass wasting features on this bank as well (Figure 2).

Figure 1. Enlargement of 1:30,000 scale geologic map by Ohlin et al. (2010) in the Scott Dam vicinity, annotations highlight greater proportion of alluvial deposits on the north side of the channel downstream of Scott Dam, including alluvium ranging in age from Holocene to Pleistocene (e.g., Qal, Qto, Qoa).

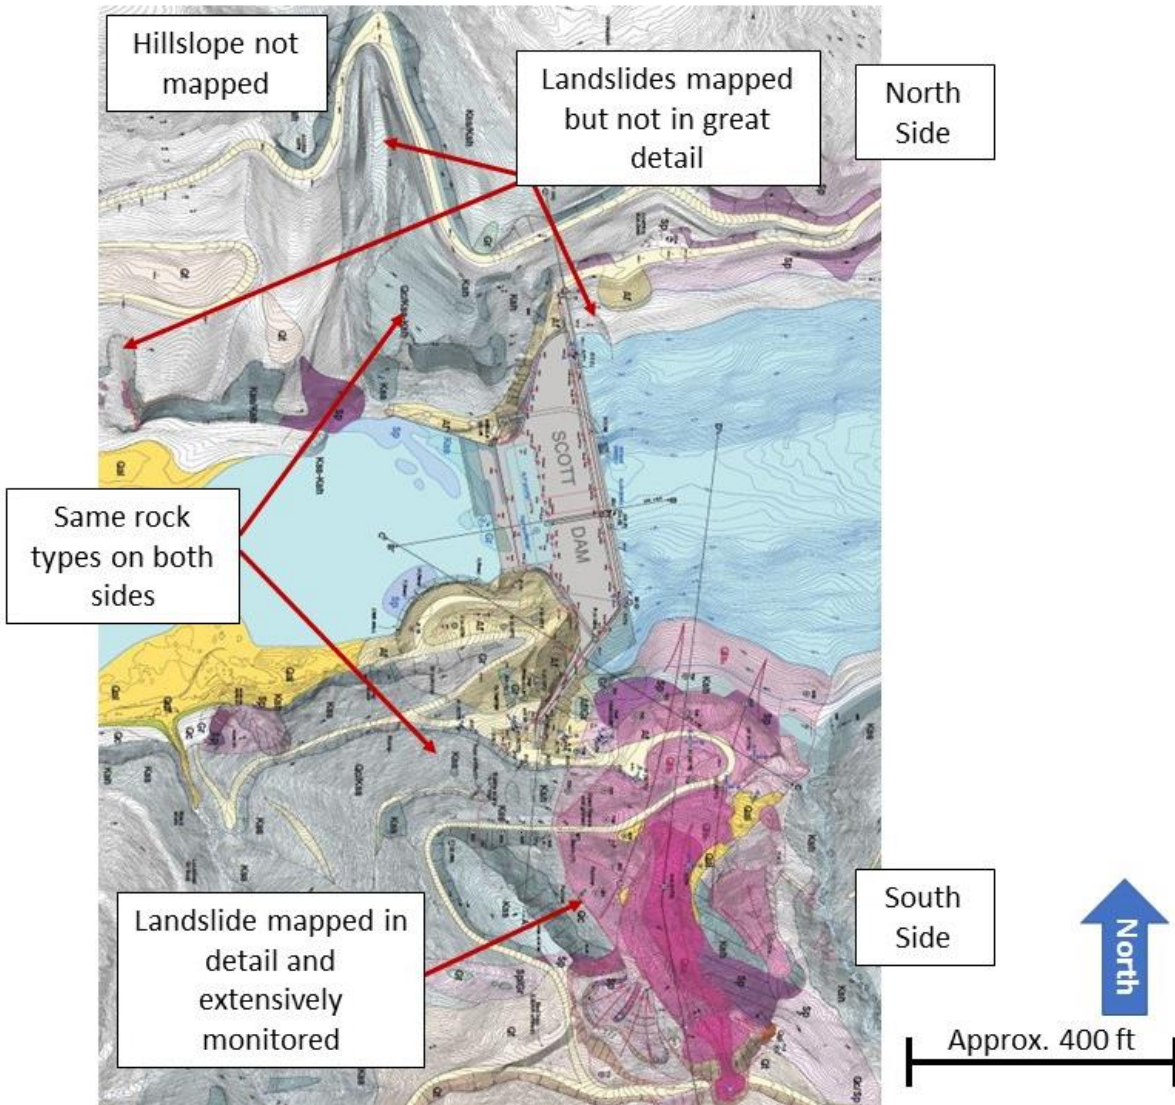
Figure 2. Detailed site geologic and geomorphic map by PG&E (2016); annotations highlight landslide mapping on both north and south banks.

Although more mass movements have been documented on the south bank (in part due to more detailed mapping and investigation focusing on the south bank), the north bank consists of a substantially larger area of alluvial deposits, suggesting that overall there may be a higher risk for future hillslope failure on the north side of the channel (thereby also suggesting the south side is a more suitable location for constructing a fish ladder); however, much of the mapping on the north side of the channel did not include mass movement activity type (e.g., slump, slide, or flow) or activity status (e.g., active, dormant, relict). Additional investigations are recommended to better identify the location and type and activity of landslide (or other mass movement) features which could affect future fish passage facilities at the site, such as aerial photograph and LiDAR review, and geomorphic mapping to better identify, map, and assess the activity of geohazards on both the north and south banks. The results of this investigation can better inform fish passage facility design (e.g., wrap-around fish ladder with shorter hillslope traverse compared to straight ladder with longer hillslope traverse) to help minimize areas of unstable (or potentially unstable) ground.
